UBIT INSPECTION REPORT

Fox Island Bridge #26211-A

August 3, 2017

On August 3, 2017 the Fox Island Bridge #23211-A was inspected using the Washington State Department of Transportation (WSDOT) under bridge inspection truck UB-62.

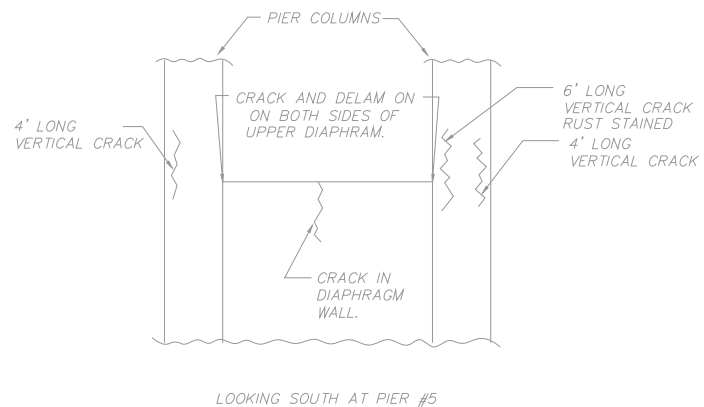
Pier 5: The steel rockers of the bearing assemblies are tipping slightly to the south. The east bearing is tipping more than the others. The pier cap has one 12" and one 6" long horizontal rusty rebar exposed in the west end of the north face. There is a 5' long vertical crack with rust staining at the top of the concrete pier wall diaphragm. (See detail) There are several transverse leaching cracks in the soffit on the cantilever (south) side of Pier 5.

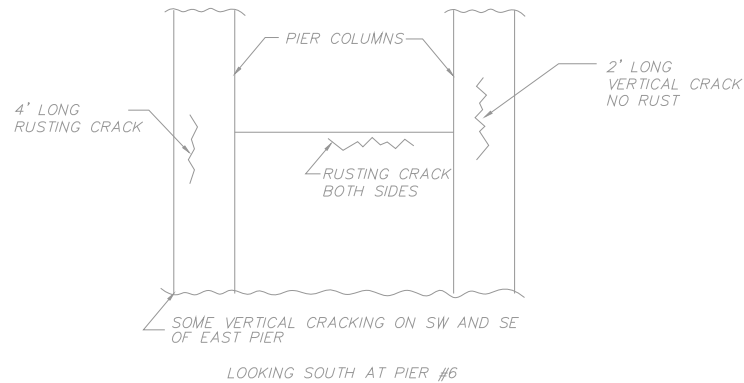
Pier 6: There are several hairline diagonal/vertical cracks in the webs of the concrete T-beams between Piers 6 and 7. The bottom flange of Girder "A" has hairline cracking. There are several transverse leaching cracks in the soffit near Pier 6. The top east side of the diaphragm has a small pop out with exposed rebar. There are several cracks in the concrete pier wall diaphragm and in the pier columns. Some of the cracks are rust stained.

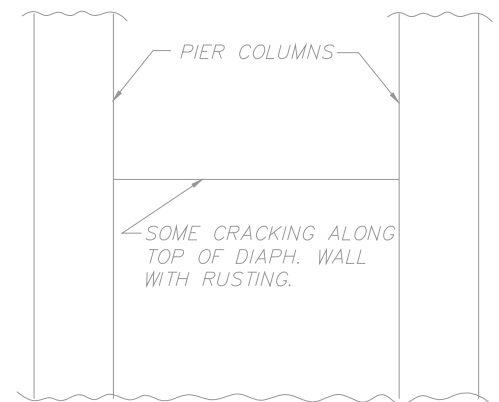
Pier 7: The top of the cap on the SW corner of Pier 7 is cracked and delaminated with 24" of exposed rusty rebar. There is minor rusting along the lower fillet of the steel drop section flange to web joint. There is some hairline cracking along the top of the pier diaphragm wall. (See detail.) The east girder has some rust stains on the bottom near pier 6. There is a spall with 4" of exposed rusty rebar on the north face of the corbel below steel beam 7C

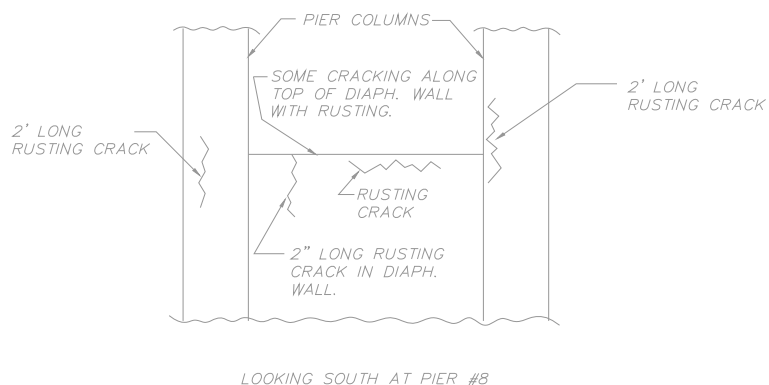
Pier 8: The center diaphragm to deck interface (SE face) has two exposed rebar. There are several transverse leaching deck cracks on both sides of Pier 8. Also, several hairline diagonal cracks in the T-beam cantilever webs. There are several hairline diagonal and vertical cracks in the T-beams between Piers 8 and 9. There are several transverse leaching cracks in the soffit near Piers 8 and 9. There are vertical rust stained cracks on the corners of the columns near the column diaphragm. (See detail.) At Pier 8, the outside face of the web of the west exterior girder has 7 exposed rusty rebar due to lack of cover.

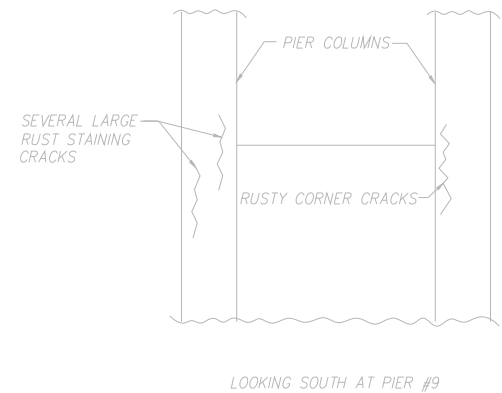
Pier 9: All four corners of the east pilaster are spalled off near the water line. There are several transverse leaching cracks in the soffit near Pier 9 on the north side. The 12' crack along the west T-beam bottom flange, reported in a previous inspection report, has been patched. The patch has cracks and is delaminating. There are three 3" diameter spalls in the web of the west T-beam near the bottom of the flange at Pier 9 with rusty rebar exposed. There are several vertical cracks in the pier columns and in the pier diaphragm walls. (See detail.)

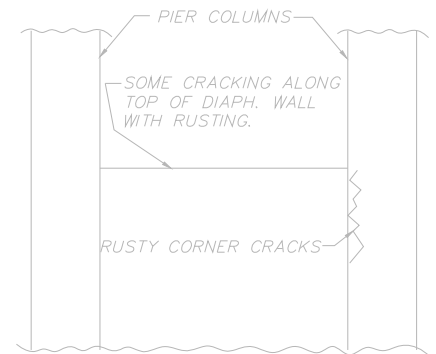
LOOKING NORTH AT PIER #13

Pier 13: There is slight pitting of paint on all three steel rocker bearing assemblies. The concrete corbel repair on the northwest corner of the steel beam span is leaching along the patch joint on both sides. There are several short leaching and/or rusting cracks along Pier 13 near and on the diaphragm. There is one 18" square hole in the pier diaphragm at about 12' below the top of the diaphragm. There are vertical cracks on some of the column corners with some spalling and delamination, however, no reinforcing steel is exposed at this time. There are a few transverse leaching deck cracks near Pier 13.

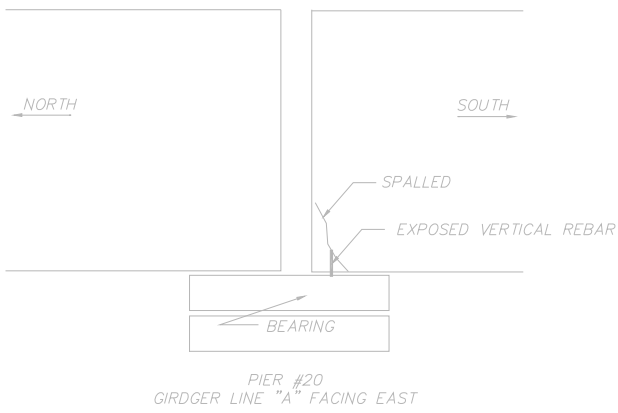
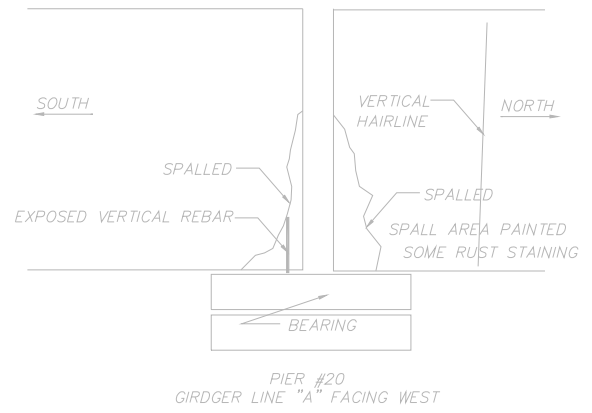
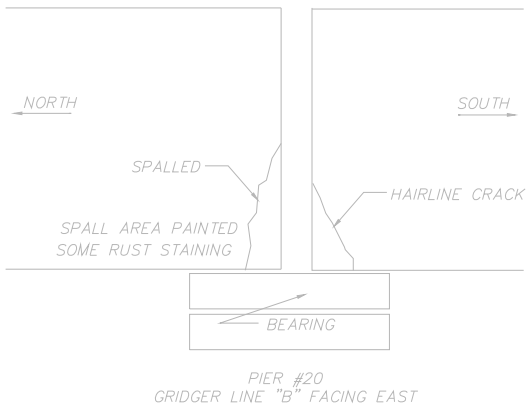
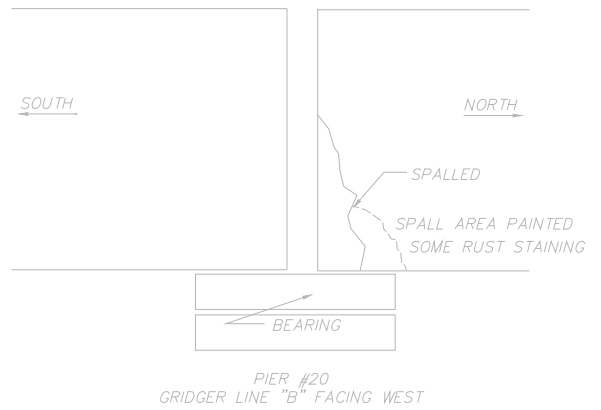
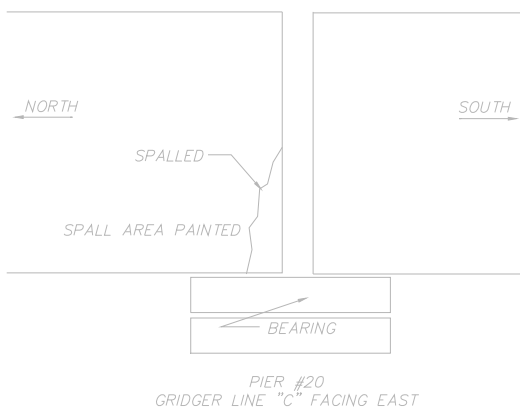
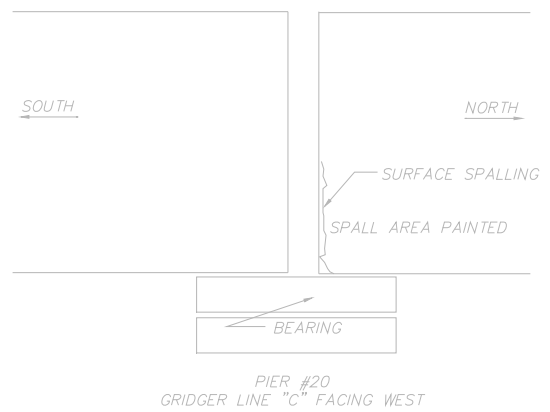
- Pier 20: The ends of the girders have diagonal spalls at the bearing. The ends of the span 20 girders have been chipped, cleaned and painted. See the following sketches:
