UBIT INSPECTION REPORT

Fox Island Bridge #26211-A

August 27, 2019

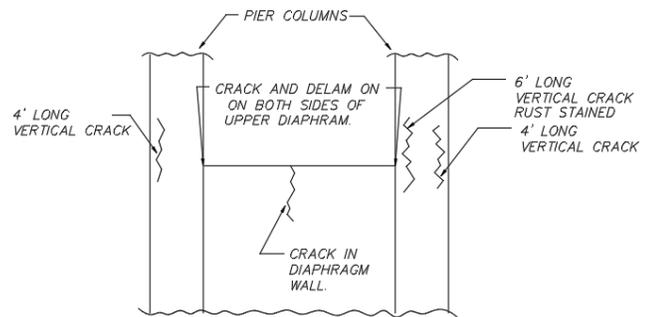
LOOKING SOUTH AT PIER #5

There is a 5'-0" long vertical crack with rust staining at the top of the concrete pier wall diaphragm (see detail).

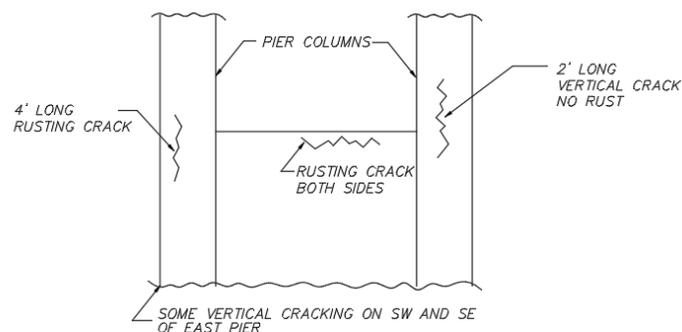
LOOKING SOUTH AT PIER #6

The top east side of the diaphragm has a small pop out with exposed rebar.

There are several cracks in the concrete pier wall diaphragm and in the pier columns. Some of the cracks are rust stained.

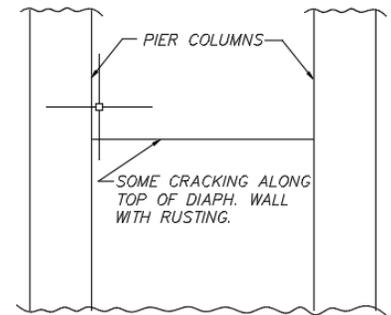
LOOKING SOUTH AT PIER #7

There is some hairline cracking along the top of the pier diaphragm wall (see detail).

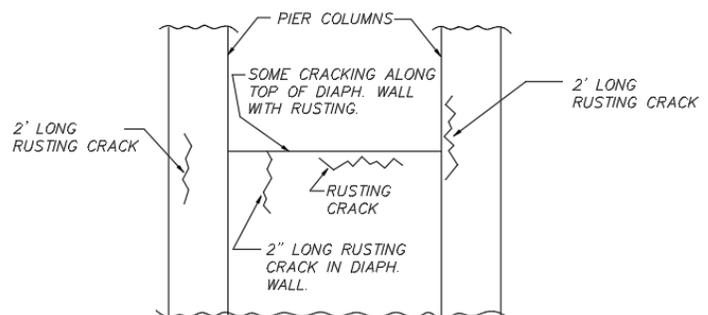
LOOKING SOUTH AT PIER #8

There are vertical rust stained cracks on the corners of the columns near the column diaphragm (see detail).

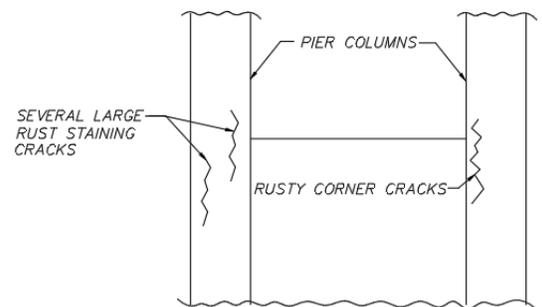
LOOKING SOUTH AT PIER #9

There are several vertical cracks in the pier columns and in the pier diaphragm walls (see detail).

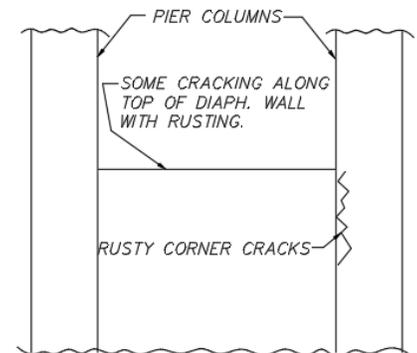
LOOKING NORTH AT PIER #13

There are several short leaching and/or rusting cracks along Pier 13 near and on the diaphragm.

There is one 18" square hole in the pier diaphragm at about 12'-0" below the top of the diaphragm.

There are vertical cracks on some of the column corners with some spalling and delamination, however, no reinforcing steel is exposed at this time.

Column A, north side, has 4 SF of delamination and rust staining.

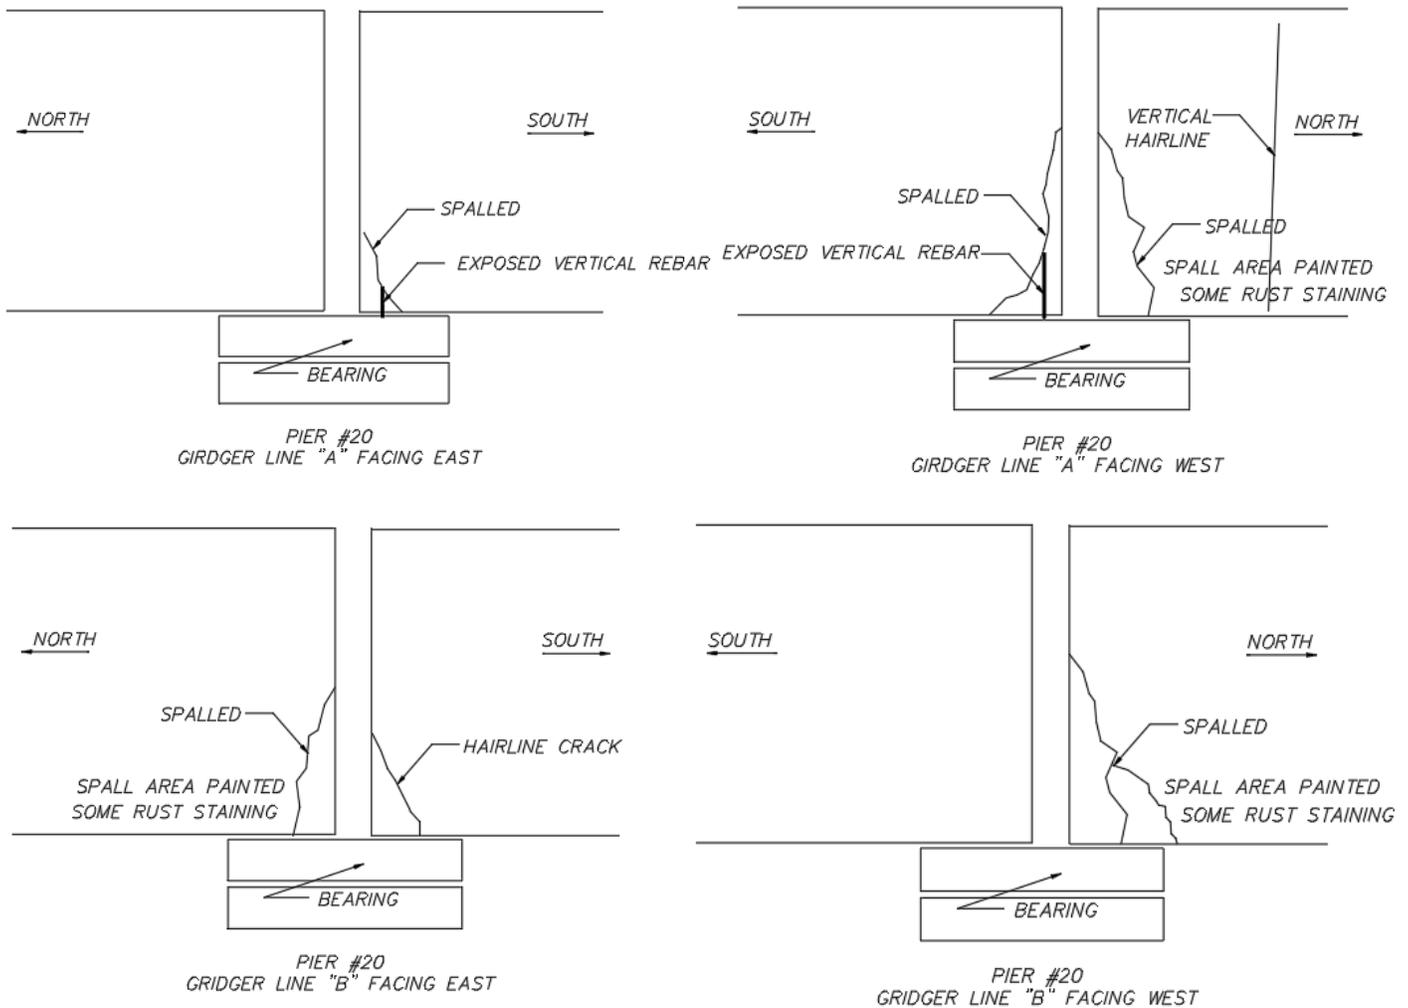
Pier 20: The ends of the girders have diagonal spalls at the bearing. The ends of the Span 20 girders have been chipped, cleaned and painted (see the following sketches).
