UBIT INSPECTION REPORT

Fox Island Bridge #26211-A

August 17, 2015

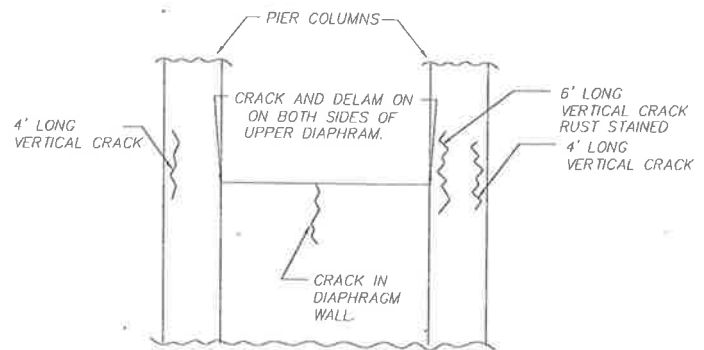
LOOKING SOUTH AT PIER #5

Pier 5: The bearings appear to be moving very little. The steel rockers of the bearing assemblies are tipping slightly to the south. The east bearing is tipping more than the others. The pier cap has one 12" and one 6" long horizontal rusty rebar exposed in the west end of the north face. There is a 5' long vertical crack with rust staining at the top of the concrete pier wall diaphragm. (see detail below) There are several transverse leaching cracks in the soffit on the cantilever (south) side of Pier 5.

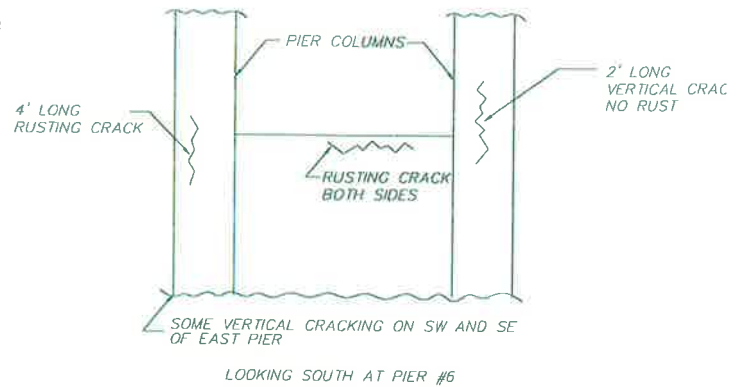
Pier 6: There are several hairline diagonal/vertical cracks in the webs of the concrete T-beams between Piers 6 and 7. The bottom flange of Girder "A" has hairline cracking. There are several transverse leaching cracks in the soffit near Pier 6. The top east side of the diaphragm has a small pop out with exposed rebar. There are several cracks in the concrete pier wall diaphragm and in the pier columns. Some of the cracks are rust stained.

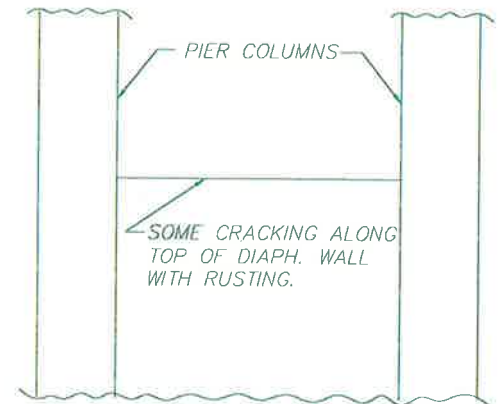
Pier 7: The top of the cap on the SW corner of Pier 7 is cracked and delaminated with 4" of exposed rusty rebar. There is an exposed stirrup bar on the north face of the cap between Girders "B" and "C" (did not see this) There is minor rusting along the lower fillet of the steel drop section flange to web joint. There is some hairline cracking along the top of the pier diaphragm wall. (See detail.) The east girder has some rust stains on the bottom near pier 6.

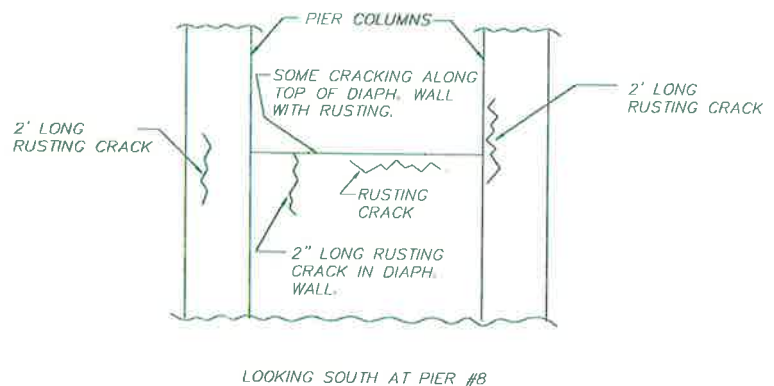
Pier 8: The center diaphragm to deck interface (SE face) has two exposed rebar. There are several transverse leaching deck cracks on both sides of Pier 8. Also, several hairline diagonal cracks in the T-beam cantilever webs. There are several hairline diagonal and vertical cracks in the T-beams between Piers 8 and 9. There are several transverse leaching cracks in the soffit near Piers 8 and 9. There are vertical rust stained cracks on the corners of the columns near the column diaphragm. (See detail.) At Pier 8, the outside face of the web of the west exterior girder has 7 exposed rusty rebar due to lack of cover.

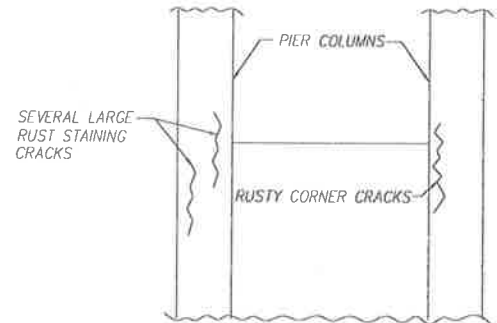
LOOKING SOUTH AT PIER #9

Pier 9: All four corners of the east pilaster are spalled off near the water line. There are several transverse leaching cracks in the soffit near Pier 9 on the north side. The 12' crack along the west T-beam bottom flange, reported in a previous inspection report, has been patched. The patch has cracks and is delaminating. There are two 3" diameter spalls in the web of the west T-beam near the bottom of the flange at Pier 9 with rusty rebar exposed. There are several vertical cracks in the pier columns and in the pier diaphragm walls. (See detail.)

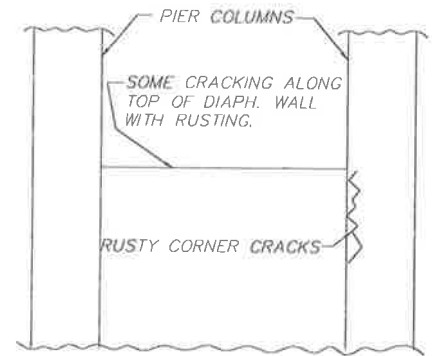
LOOKING NORTH AT PIER #13

Pier 13: There is slight pitting of paint on all three steel rocker bearing assemblies. The concrete corbel repair on the northwest corner of the steel beam span is leaching along the patch joint on both sides. There are several short leaching and/or rusting cracks along Pier 13 near and on the diaphragm. There is one 18" square hole in the pier diaphragm at about 12' below the top of the diaphragm. There are vertical cracks on some of the column corners with some spalling and delamination, however, no reinforcing steel is exposed at this time. There are a few transverse leaching deck cracks near Pier 13.

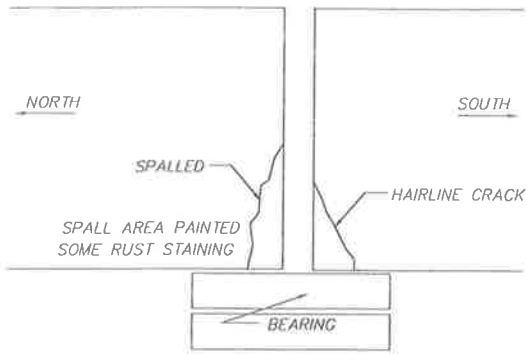
PIER #20
GRIDGER LINE "B" FACING EAST

Pier 20: The ends of the girders have diagonal spalls at the bearing. The ends of the span 20 girders have been chipped, cleaned and painted. See the following sketches:
