CHAPTER EIGHT

Stream Habitat and Riparian Areas Analysis

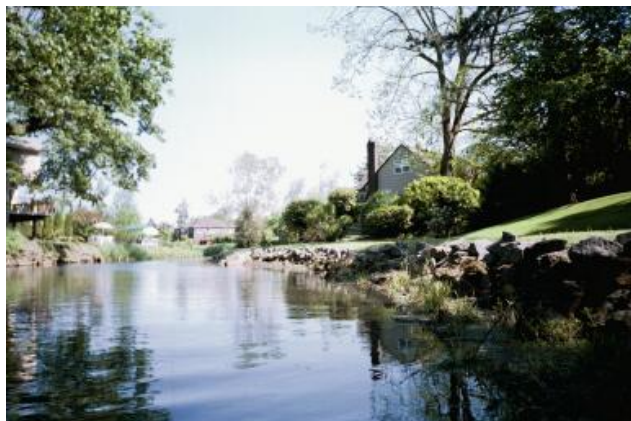
Habitat field evaluation identified unstable and eroding streambanks in the canyon and floodplain reaches of nearly all streams within the Basin. Erosion problems in canyon reaches are generally characterized by unstable banks cut by high peak streamflow rates. Channel

widening and downcutting (as described in the previous section) were observed throughout the stream systems. Channel widening due to sedimentation is the main erosion problem in the floodplain reaches. High stream flows in the canyons transport eroded sediments downstream into the floodplain reaches, where sediments settle out in low-gradient backwater reaches. Typically, a depositional channel will widen in order to re-establish the conveyance capacity of the stream.

Stream bank and stream bed erosion is a serious problem in all watersheds in the Clear/Clarks Creek Basin. For example, Swan Creek has sections where the channel has downcut as much as 12-feet with vertical banks. There was one area of serious slumping located on Swan Creek about 1,500 feet below 64th Street East.

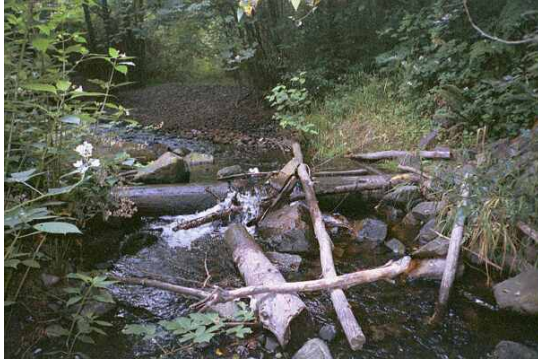
The tremendous hydraulic power of peak flows and the associated bedload movement of cobble and gravel are demonstrated by the condition of a recent bed stabilization project in the 0.5-mile-long reach below 64th Street East. A series of log “V” weirs were installed in the mid-1990s. When observed in 2001, about half of these weirs had washed away (they were sequentially numbered and marked) and the other half were not functioning. Most of the remaining weirs

were almost completely buried with gravel on both the upstream and downstream side of the weir. This reach was dry in July 2001.
