UBIT INSPECTION REPORT

Fox Island Bridge #26211-A

August 17, 2015

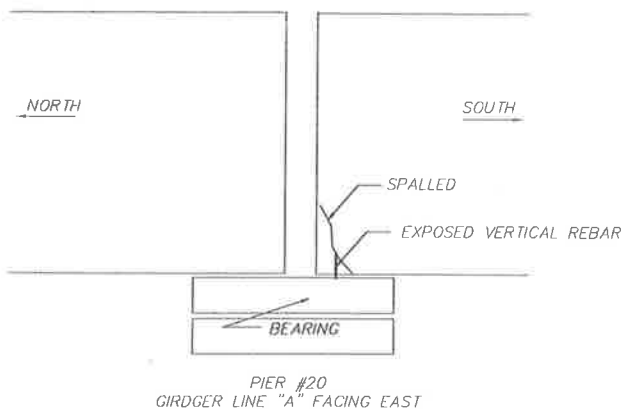
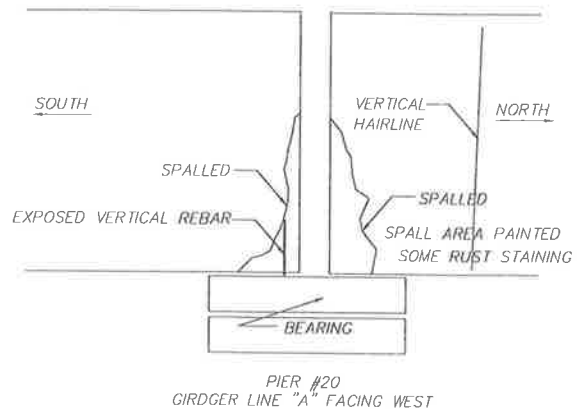
Pier 20: The ends of the girders have diagonal spalls at the bearing. The ends of the span 20 girders have been chipped, cleaned and painted. See the following sketches:
