EXECUTIVE SUMMARY

PROJECT BACKGROUND AND PURPOSE

Pierce County is conducting the Lower Puyallup River Flood Protection Investigation to address significant flood-related issues affecting communities along the Lower Puyallup River. Under federal flood-management guidelines, these communities are facing restrictions on properties within a broad area that is newly defined as floodplain, based on recent floodplain maps developed by the Federal Emergency Management Agency (FEMA).

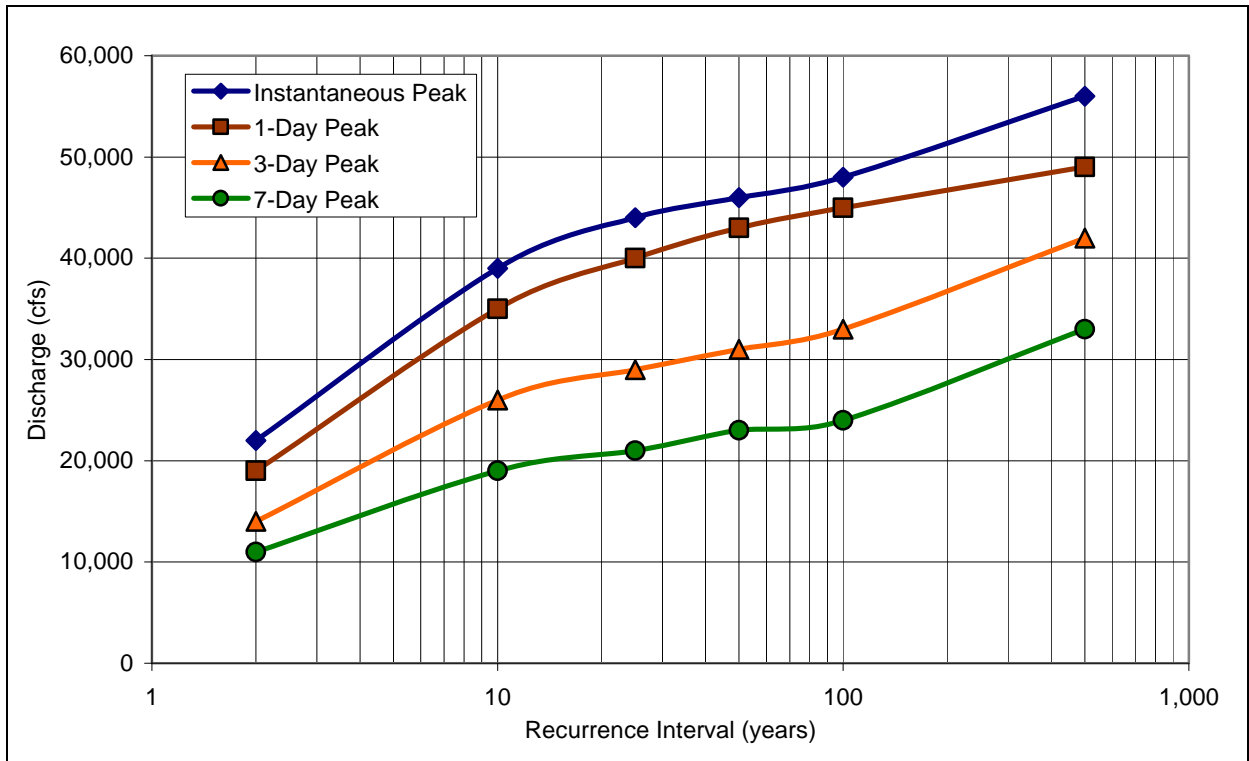
Figure ES-2. Peak Flows Estimated in Without-Project Analysis

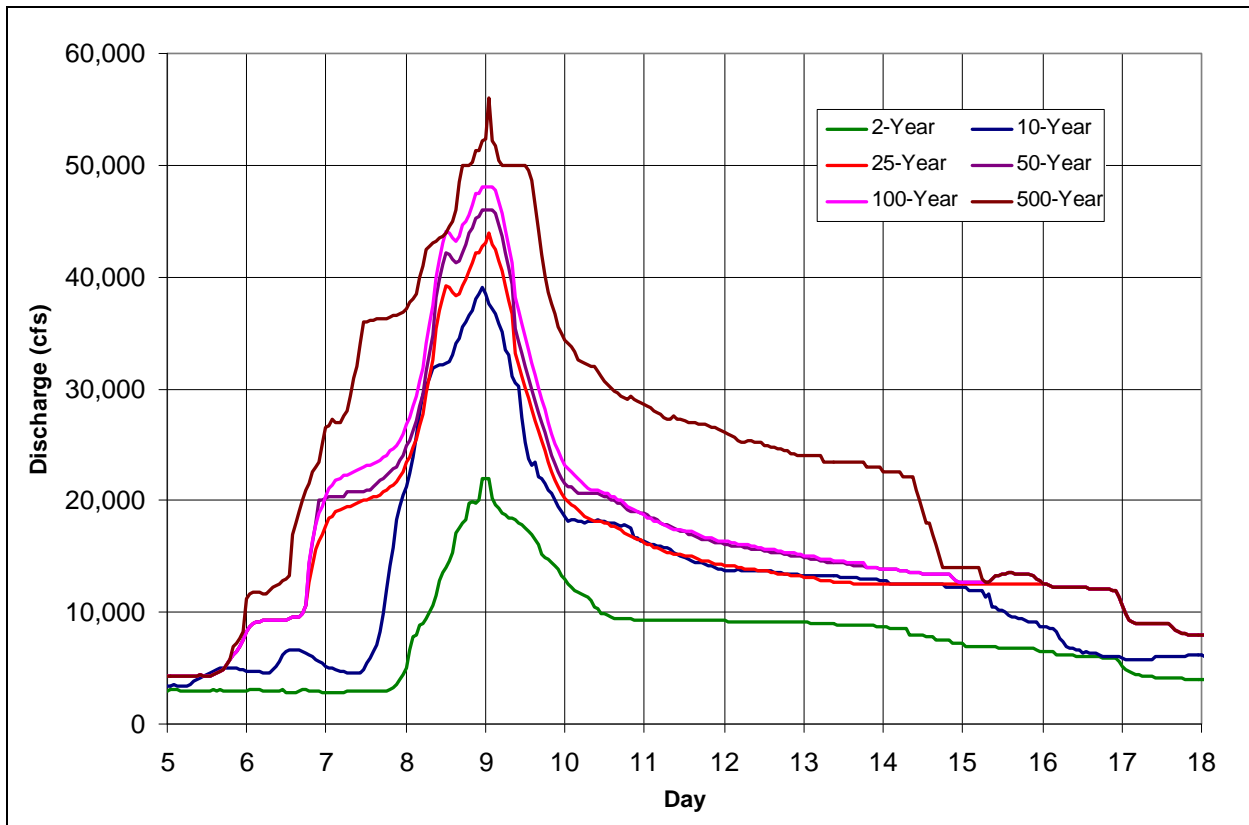
Figure ES-3. Design Hydrographs for the 2- through 500-Year Flood Events

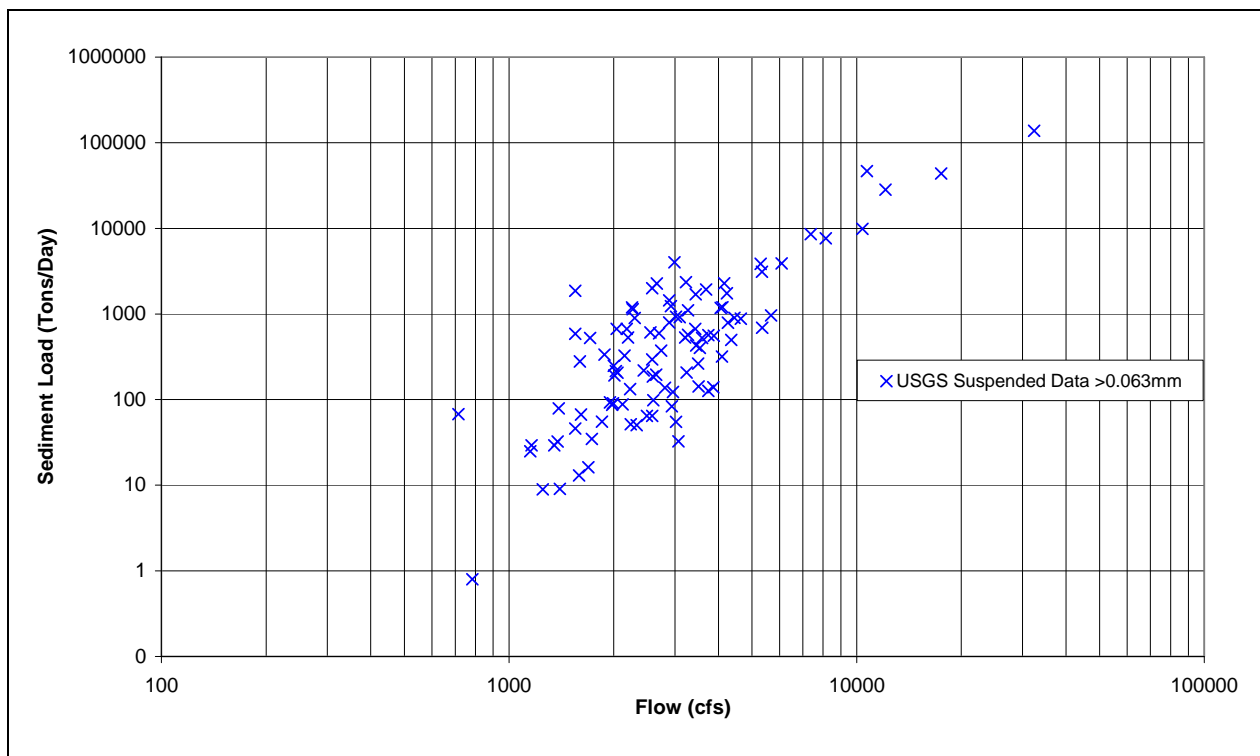
Figure ES-4. Sediment Rating Curve for Puyallup River at Puyallup Gage (12101500), 1978–1994

The river-bed sediment is a poorly graded sand, with a median particle diameter of 0.35 mm (medium sand). The quantity of sediment suspended in the river varies with river flow, as shown in Figure ES-4.
