SUB-SECTION 4.G3

REGION 5 HAZARD MITIGATION PLAN LANDSLIDE HAZARD SUB-SECTION¹

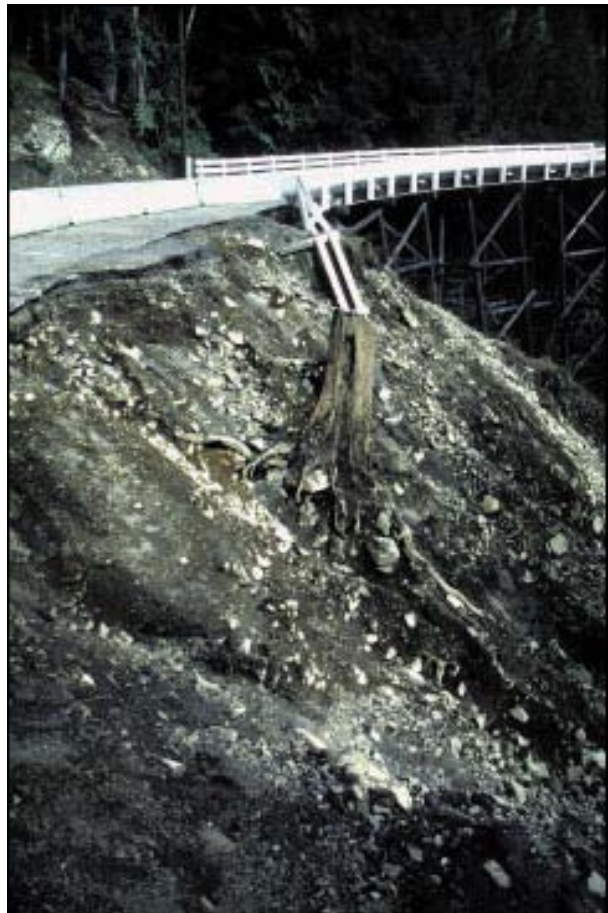
Figure 4.G3-3 SR-165 Bridge along Carbon River – Landslide 2/1996

⁶ Landslides and Landslide Hazards in Washington State Due to February 5-9, 1996 Storm--U.S. Geological Survey Administrative Report-- Debris flow undermining abutment of bridge across the Carbon River on Washington SH-165 south of Carbonado, Washington.

DATE	DESCRIPTION
2006 (Federal Disaster #1671)	Estimated ten plus inches of rain in the lowlands (4-5 day period) and 18 plus inches up on Mt. Rainier (36hr period). The Carbon River experienced numerous slides in the vicinity- East of Orting and North of 177 th . Major landslides also occurred in Mt. Rainier National Park closing the Park.
2006	After receiving rain for 31 of 33 days in January and February landslides occurred in various areas throughout the County.
2001 (Federal Disaster #1361)	During the February 28 th earthquake, a portion of the hillside above Salmon Beach slid down the hill, damaging a number of homes and destroying electric service and physical access to the community.
1996 (Federal Disaster #1159)	About 20-30 landslides occurred in the region. The slides damaged or destroyed eight homes and damaged utility lines; a landslide south of DuPont pushed two locomotives and two rail cars into Puget Sound, spilling 3,000 gallons of fuel; damaged State Route 165 and undermined a bridge abutment at the Carbon River near Carbonado.

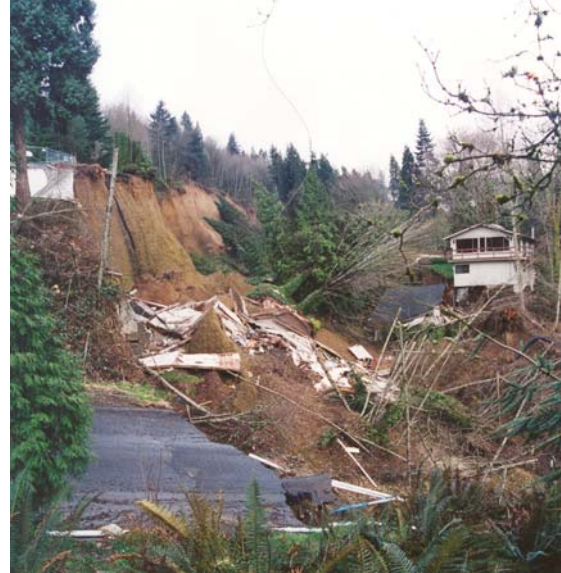
Figure 4.G3-4 Aldercrest Drive – Landslide 1/1999

Financially, while a landslide within the boundaries of any jurisdiction could cause some strain, the limited area covered should limit the actual financial hardship to the local jurisdiction. There are areas that slide on a regular basis in both the unincorporated areas of the County and within the City of Tacoma. These are handled yearly with the local budgets and to date have not stressed the budget. If any area of Pierce County were to experience a landslide of the proportions of the Aldercrest-Banyon landslide in Kelso and the subsequent Haussler Road Landslides on the opposite side of the ridge in 1999, it could cause financial difficulties due to the streets and other utilities affected or destroyed; see Figure 4.G3-4.
