7. WATER QUALITY PROBLEMS ANALYSIS

7.1 Site-Specific Issues

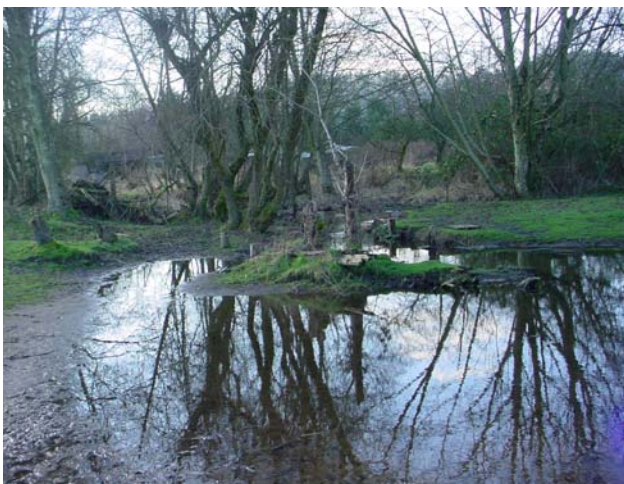
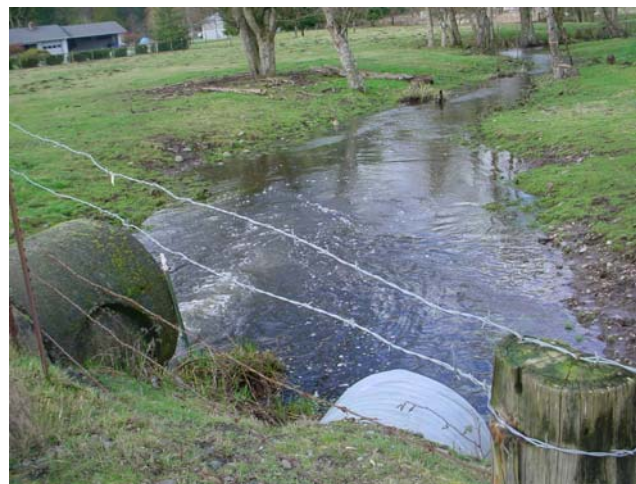
Figure 7-1
Examples of Degraded Stream Banks on Ball and Horsehaven Creeks

Bank erosion along stream channels contributes to elevated turbidity levels, sediment accumulations, degraded habitat, and can cause other property damage. In agricultural areas such as the valley portion of the Mid-Puyallup Basin, lack of vegetated stream corridors expose stream banks to wind and rain, increasing their susceptibility to erosion. Allowing livestock access to streams damages stream banks. Livestock trample the banks and destroy vegetation. Citizens have reported that livestock continue to have access to Horsehaven Creek in some areas. Increased urban development also affects stream bank erosion by changing hydrology patterns and increasing erosive peak flows.

Three of the Mid-Puyallup tributaries—Alderton Creek, Ball Creek, and Horsehaven Creek—flow along the flat valley bottom and have unprotected stream banks through agricultural areas.

The low gradient of these creeks compounds the problem by making it difficult for sediments from bank erosion to be flushed downstream. All three of these creeks have thick layers of fine material covering their gravel beds and smothering spawning gravel. This fine sediment reduces the flow of oxygen rich water to developing eggs and fills cobble spaces where insects live that provide food for developing fingerlings.

An investigation into the primary sources of sediment on each of these streams would be beneficial in focusing restoration efforts most effectively. Reduction in sediment input is essential to stable restoration and long-term recovery of these streams for salmonid habitat. A study, ST-1, is recommended in [Chapter 9](#) to obtain this information.

Solutions to bank erosion overlap with solutions to several other water quality and habitat issues in this basin. These solutions include mitigating for increases in stormwater volume due to urban growth, planting streamside riparian areas, restricting livestock access to creeks, and educating the public about what is important for channel integrity. Stormwater mitigation (such as regional detention ponds, on-site facilities, or low impact development techniques) helps reduce hydrologic impacts from urbanization that can scour and damage stream banks. Programmatic recommendations [PRG-23-01](#) and [PRG-00-02](#) in [Chapter 9](#) will help reduce urban impacts, which will reduce stream bank erosion. Vegetation along streams provides root structures that support bank integrity, limit livestock access to the stream and thereby prevent trampling of the banks, and provide a source of woody debris that can deflect flowing water from banks and increase channel complexity. Program [PRG-00-05](#) described in [Chapter 9](#) will provide for revegetating riparian corridors along the Mid-Puyallup tributaries. Limiting livestock access to creeks reduces bank erosion caused by trampling damage. Restricting livestock from creeks also helps to reduce fecal coliform bacteria levels in the creeks. Providing incentives and educating landowners adjacent to streams helps bring bank and stream protection to a local level and provides people with a sense of stewardship in their own backyard. Program [PRG-00-06](#) described in [Chapter 9](#) provides public education for this purpose.
